## LABORATORY REPORT

### DESCRIPTION:

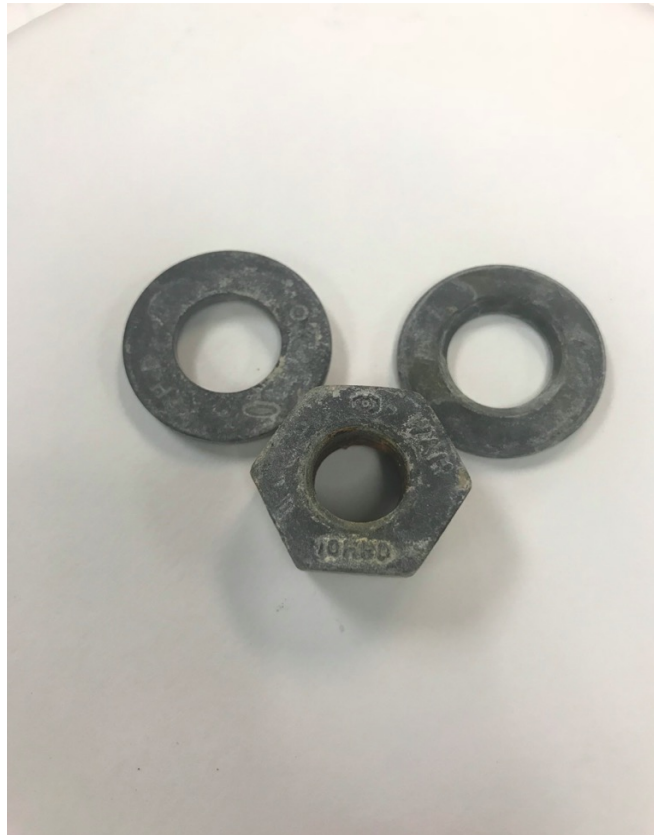
Parts were processed in **ArmorGalv**® thermal diffusion production equipment to the UPDATED **ArmorGalv**® **5000 Process** WITH 25-40 $\mu$  coating. They were put into the NSS cabinet on JULY 24, 2017. The parts were observed every 24 hrs for the first signs of Red Rust. The rust appeared on MAY 7, 2018(10 MONTHS) and were removed from the salt spray cabinet.
