## *Florida Department of Transportation*

### **Evaluation of ArmorGalv<sup>®</sup> under Salt Fog Exposure and Partial Immersion in Saltwater**

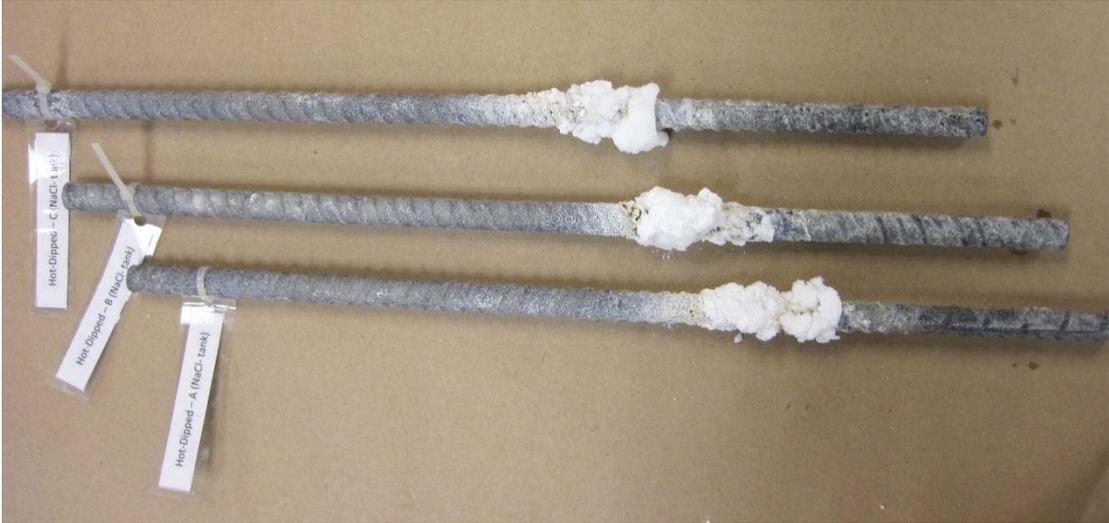
Figure 1 Traditional Hot Dipped galvanizing after 10,700 hours partial immersion

Partial immersion in the 3.5% saltwater revealed performance differences between the two specimen types. There was some visible steel corrosion occurring on the hot dipped galvanized bars at the water line, with no visual corrosion in the submerged portion. (Figure 1.) In addition, copious amounts of zinc oxide was visible just above the water line indicating that as expected,

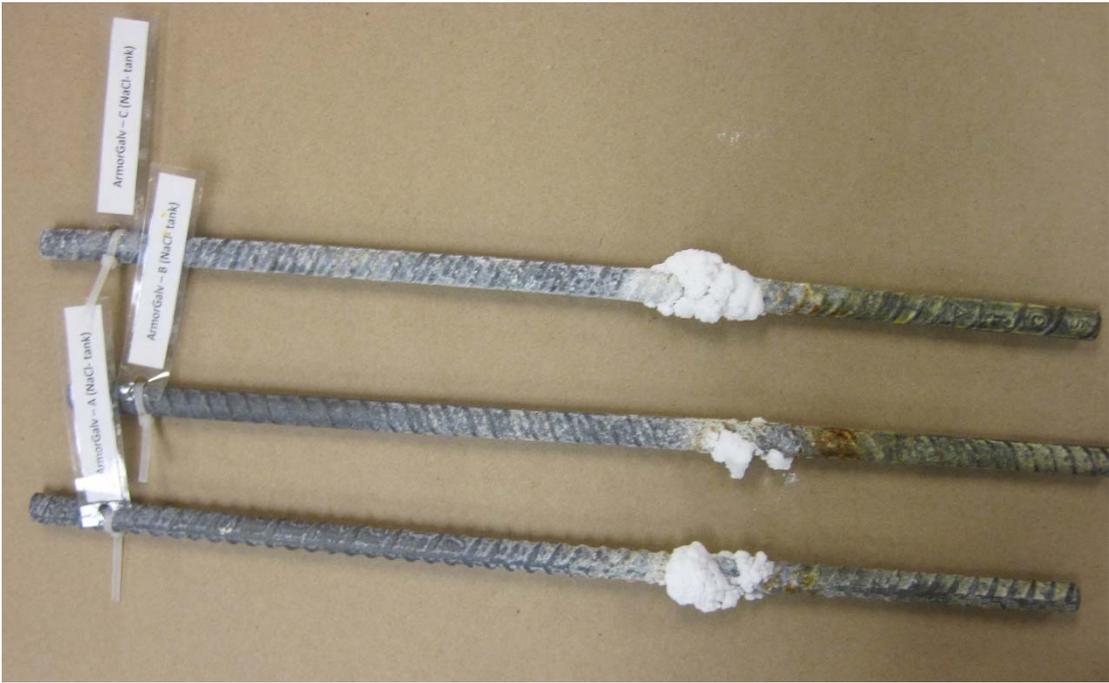
Figure 2 Armorgalv<sup>®</sup> process after 10,700 hours of partial immersion

the zinc served as a sacrificial coating. The ArmorGalv<sup>®</sup> process has visual signs of steel corrosion below the water line. (Figure 2.)

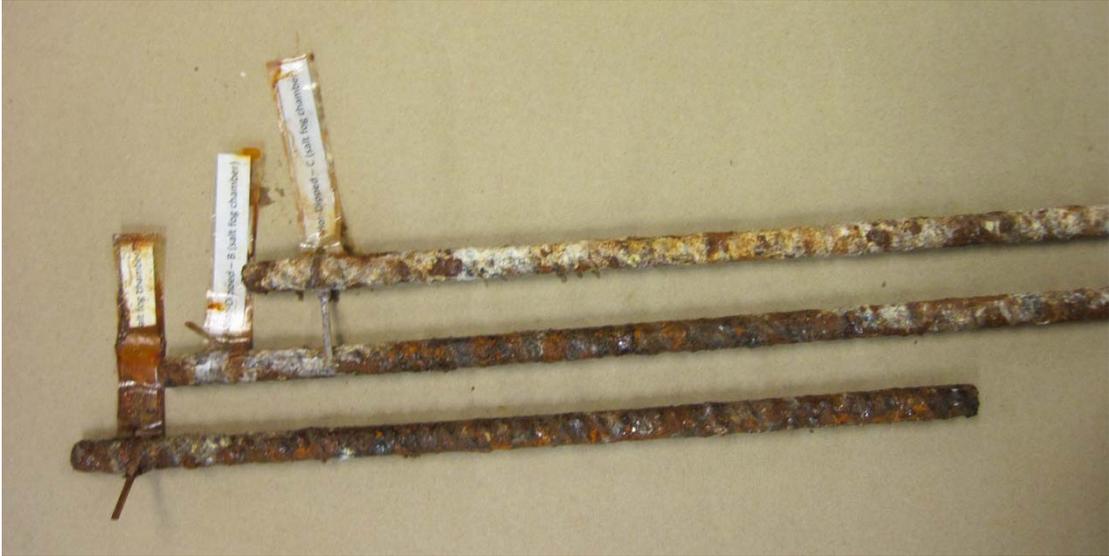
Figure 3 Traditional Hot Dipped galvanizing after 10,700 hours in salt fog exposure

The salt fog exposure revealed large differences between the two specimen types. The hot dipped galvanized bars exhibit almost complete Zinc consumption on all three specimens. (Figure3.) The ArmorGalv<sup>®</sup> process showed limited visual signs of corrosion. (Figure 4.) There are several rust colored stains that are most likely the result of surface contamination.

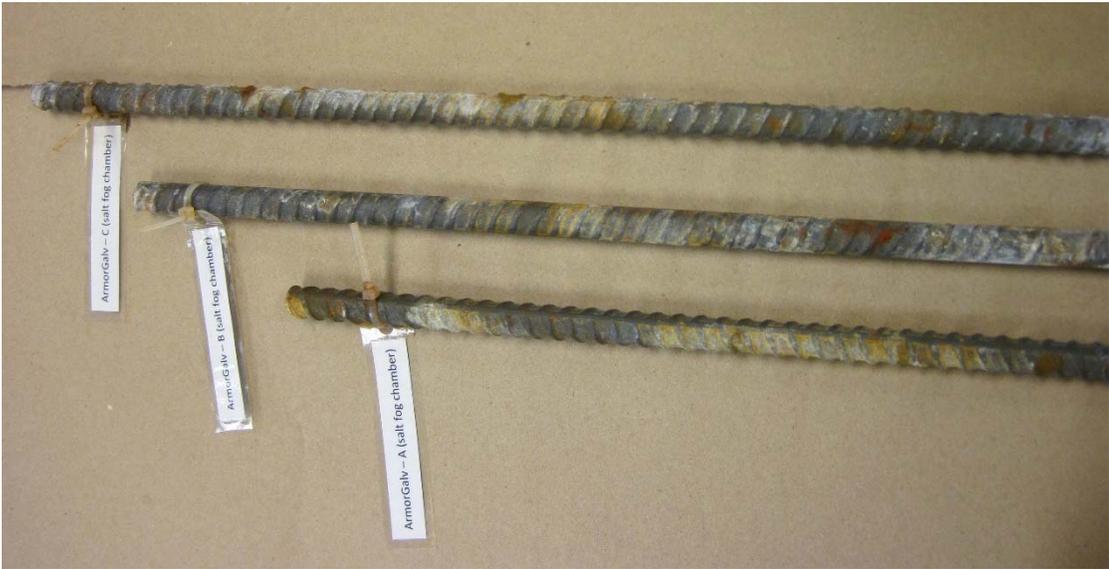
Figure 4 Armorgalv<sup>®</sup> process after 10,700 hours in salt fog exposure
